Case Study on Air India Flight -171 Crash

Abstract:

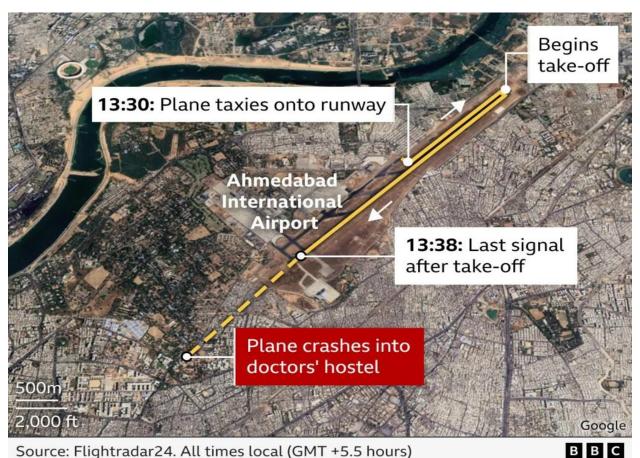
Figure-3 Flight Path of Air India AI-171: Final Moments Before Crash

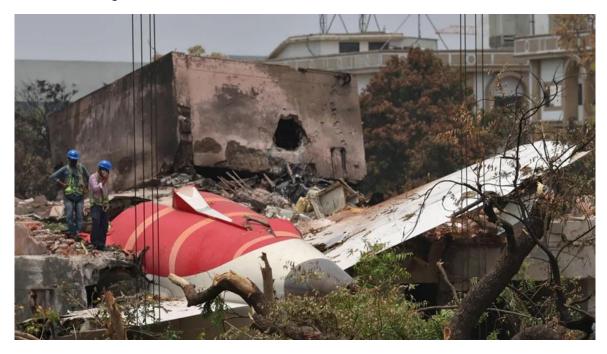
Figure-4 Indian Army Engineers Mobilized to Remove Flight AI-171 Wreckage

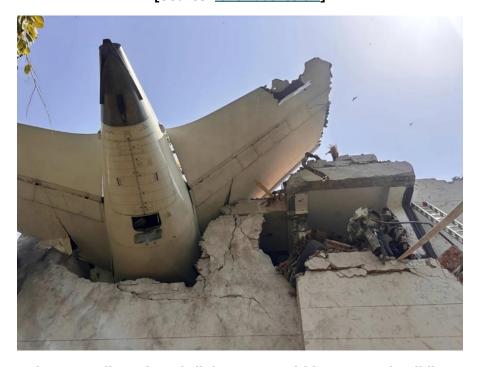
Figure-5 Tail Section of Flight AI-171 Within Impacted Building

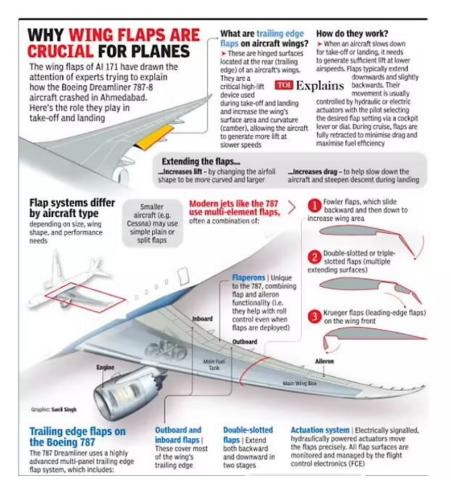
Figure-6 Why are wing flaps crucial in plane?

Aviation experts have told the BBC the position of the plane's wing flaps as it took off may have caused a problem for the plane. One video verified by the BBC shows the plane descending before a large explosion occurs as it hits the ground. "When I'm looking at this, the undercarriage is still down but the flaps have been retracted," aviation analyst Geoffrey Thomas said. Another expert, Terry Tozer, said: "It's very hard to say from the video for sure, it doesn't look as if the flaps are extended and that would be a perfectly obvious explanation for an aircraft not completing its take-off correctly." "That would point to potential human error if flaps aren't set correctly," said Marco Chan, a former pilot and a senior lecturer at Buckinghamshire New University. "But the resolution of the video is too low to confirm that."
